Shock absorber bolt repair Citta

JMPB Parts comes with a solution for damaged threads on your Gilera Citta shock absorber bolts. (See image 1)

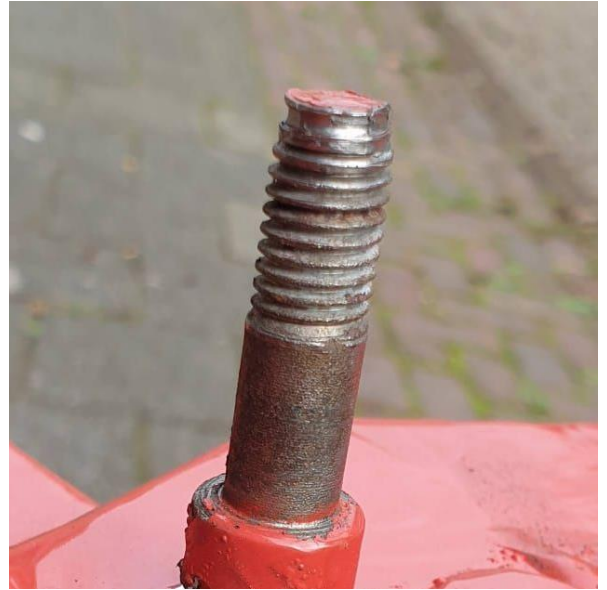
Image 1: What if your bolt looks like this?

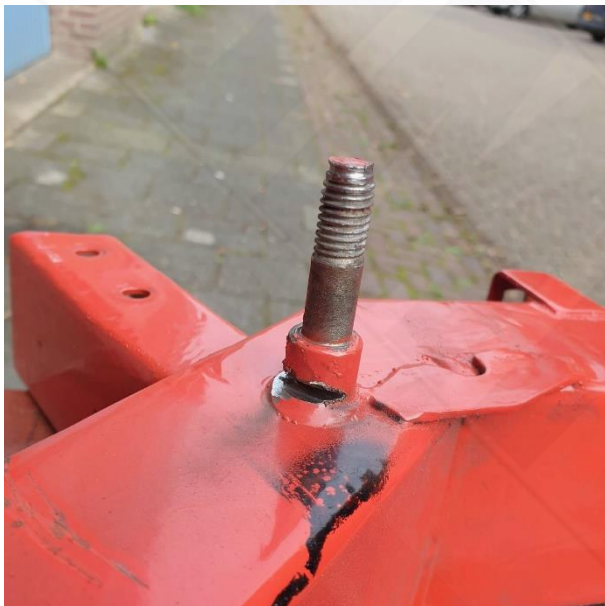
Image 2: Cut of the damaged bolts

Step 1: Cut of the old damaged bolts. Repeat this step on the other side. (See image 2)

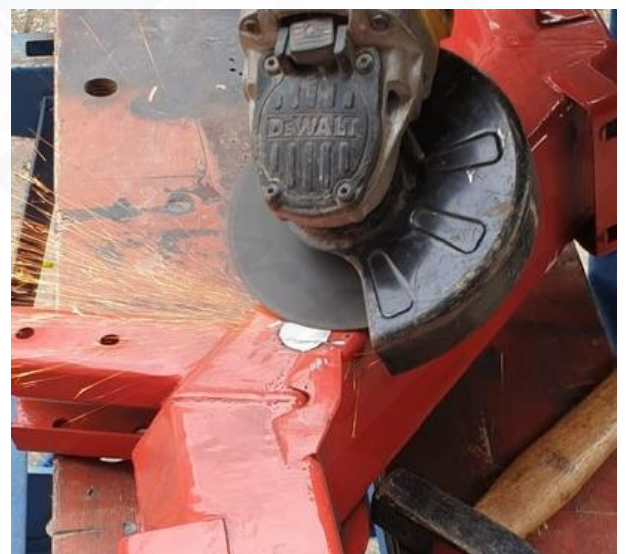
Image 3: Clean up the surface

Step 2: Clean up the surface on both sides of the frame. Make sure that the material on the sides of the frame doesn't get too thin. (See image 3)

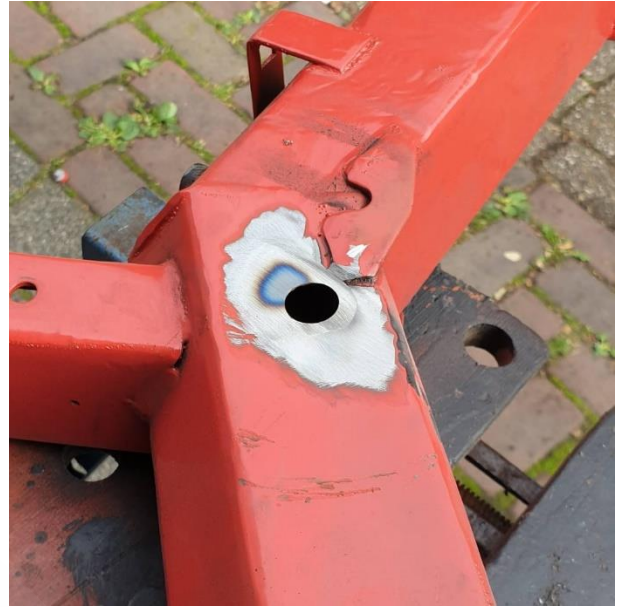
Image 4: Hole for the new shock absorber bolt

Step 3: Drill a hole (\varnothing 15mm) on both sides of the frame. Make sure that both holes are aligned with each other. (See image 4)

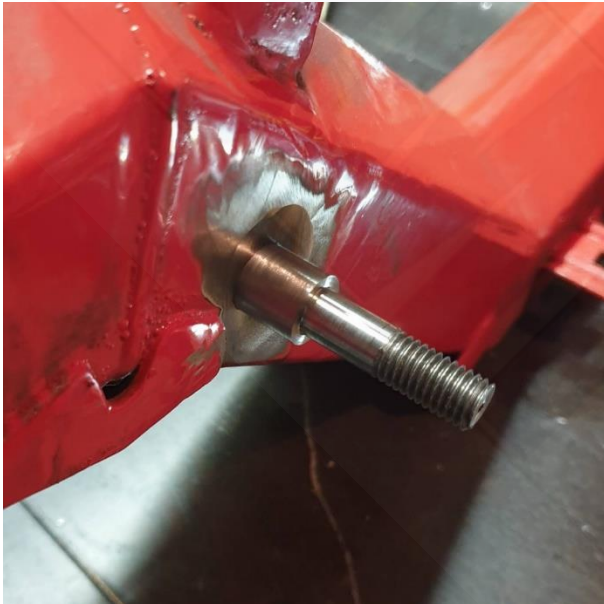
Image 5: Center the new shock absorber bolt

Step 4: Center the new shock absorber bolt in the frame. Make sure that the length of the bolt is equal on both sides. (See image 5)

Step 5: Weld the new bolt to the frame on both sides. Make sure that the weld seals of the hole in order to prevent leakage.
